Property Inspection Report

1234 Main Street, Anytown, IL 60901
Inspection prepared for: Harry Homeowner
Real Estate Agent: -

Date of Inspection: 1/20/2023 Time: 11:00 AM
Age of Home: 1973 Size: 2000
Order ID: 4349

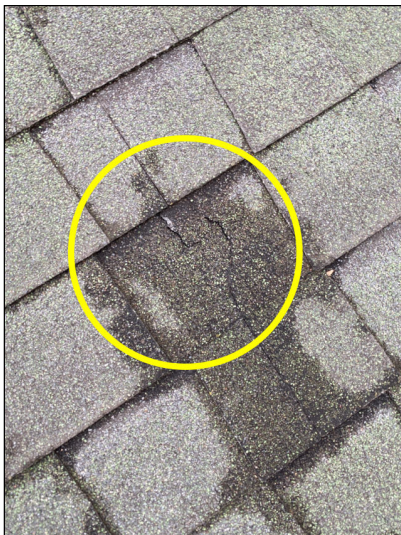
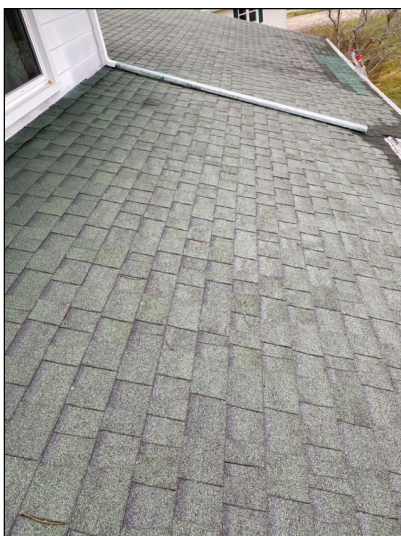
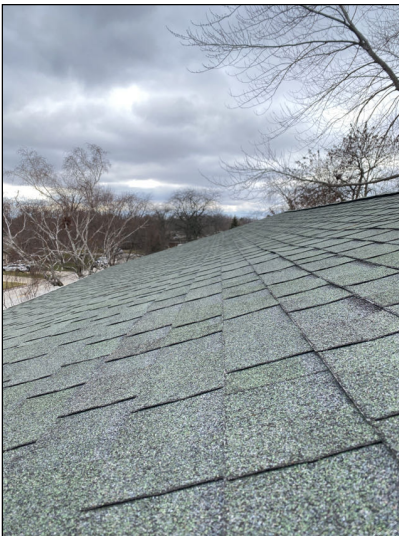
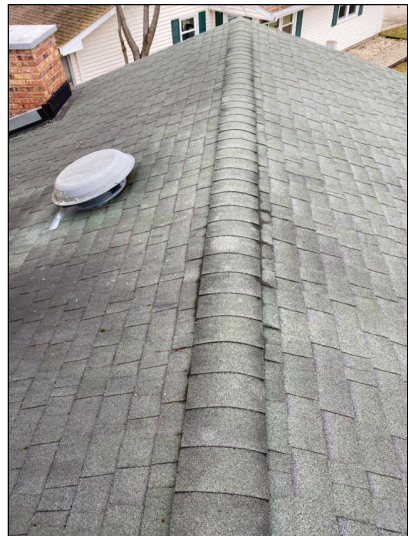
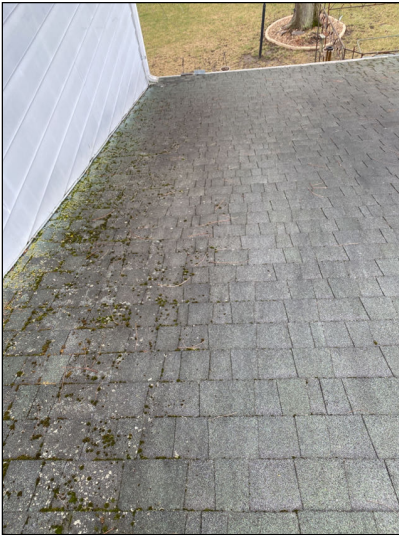
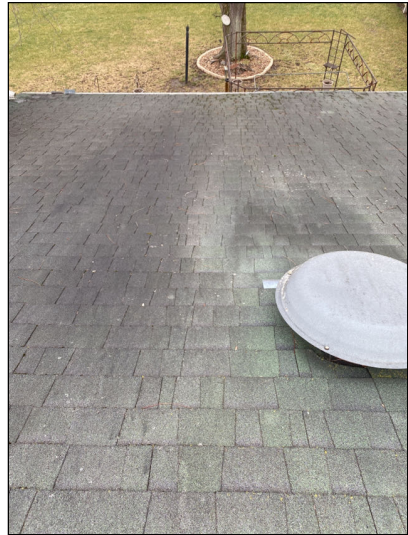
1. Roof Condition

- Mechanical/physical damage is present at main roof. In my opinion this can allow water leakage or water entry into the building. Water leakage can lead to further damage to the building including damages to structural framing. Corrective action by a qualified roofing contractor is recommended.

Roof		
Page 7 Item: 1	Roof Condition	<ul style="list-style-type: none"> Mechanical/physical damage is present at main roof. In my opinion this can allow water leakage or water entry into the building. Water leakage can lead to further damage to the building including damages to structural framing. Corrective action by a qualified roofing contractor is recommended.
Page 9 Item: 3	Chimney Condition	<ul style="list-style-type: none"> There appears to be active water leakage. In my opinion this can lead to damage to the building if not corrected immediately. Problems associated with water leakage can include damages to interior and/or finished surfaces. I recommend you contact a qualified roofing contractor to mitigate the situation.
Structure		
Page 18 Item: 5	Roof Framing Condition	<ul style="list-style-type: none"> Signs of active water leakage/seepage are present in the roof. In my opinion water leakage can cause various problems and damages. It can even lead to structural problems. I recommend you contact a qualified roofer to correct the issue.

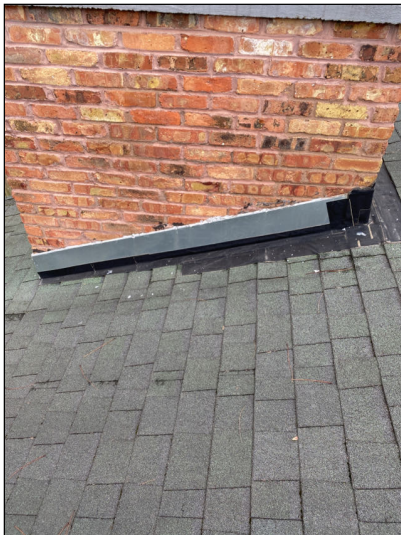
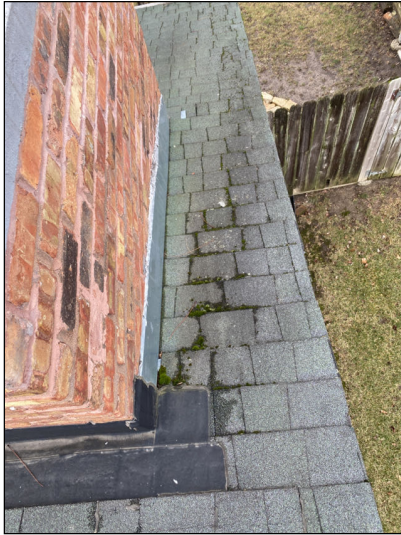
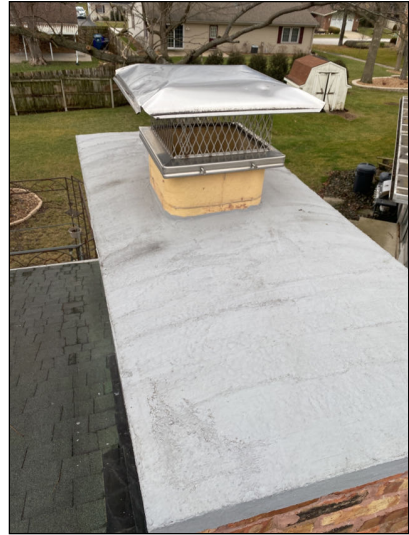
3. Chimney Condition

- There appears to be active water leakage. In my opinion this can lead to damage to the building if not corrected immediately. Problems associated with water leakage can include damages to interior and/or finished surfaces. I recommend you contact a qualified roofing contractor to mitigate the situation.

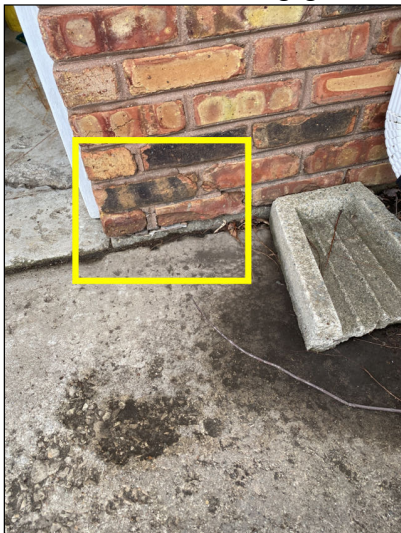
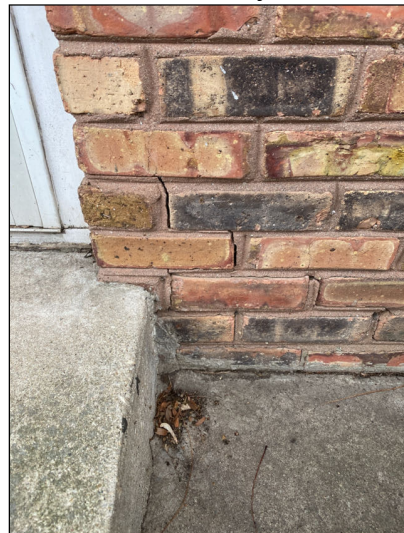
5. Siding Condition

- Cracks are present in the masonry. In my opinion these are common cracks that are often found in masonry walls. The brick wall should be inspected on an annual basis to see if the crack is getting worse. Should the cracking get worse appropriate corrective action will likely be necessary.

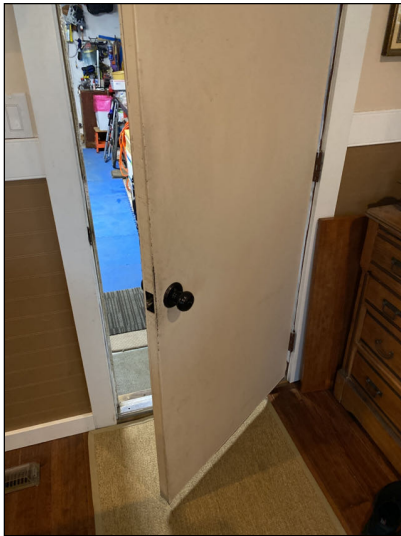
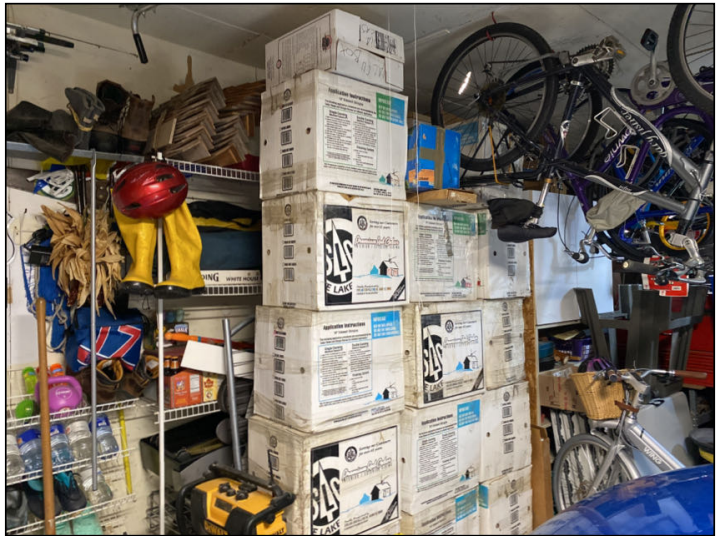
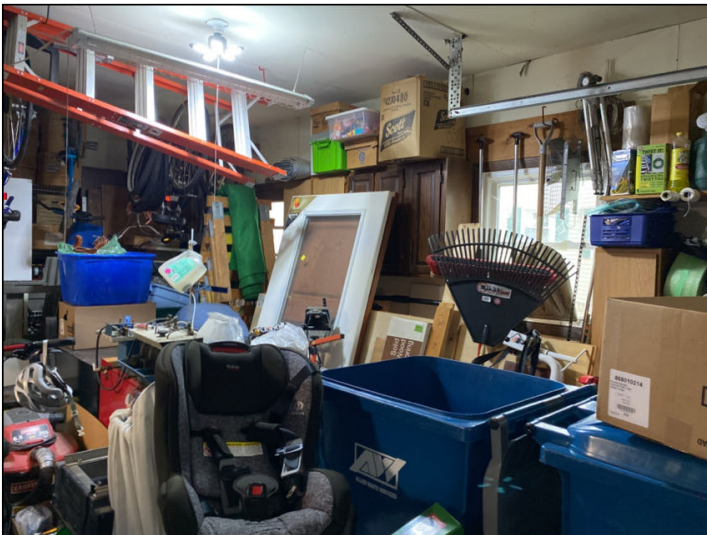
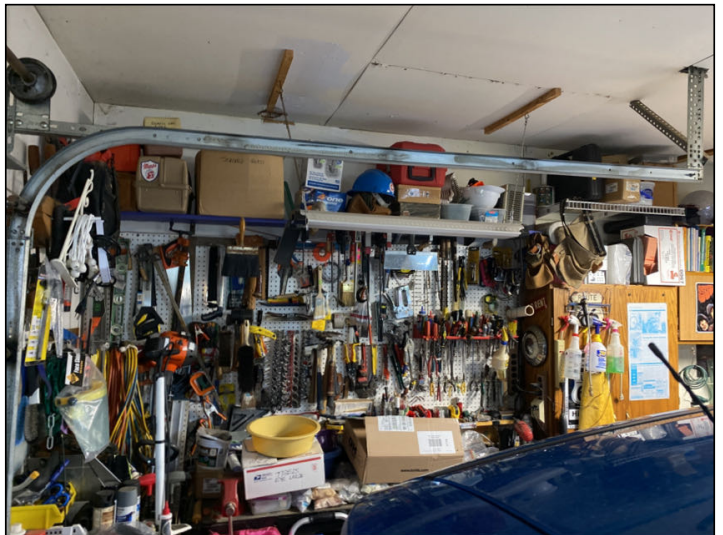
6. Garage Condition

- The garage passage door into the house is not equipped with an automatic door closer mechanism. In my opinion this is unsafe and is considered a fire/fume hazard from the garage. Installation of appropriate door closer is recommended by a qualified contractor.

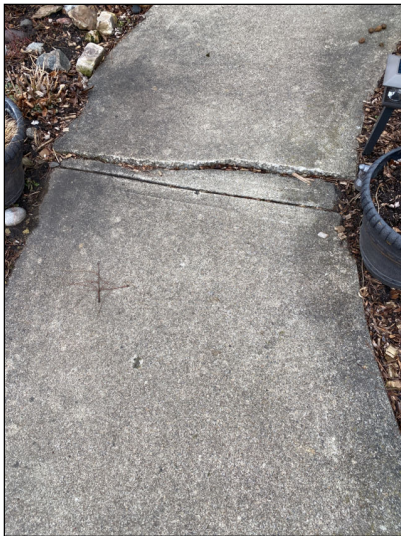
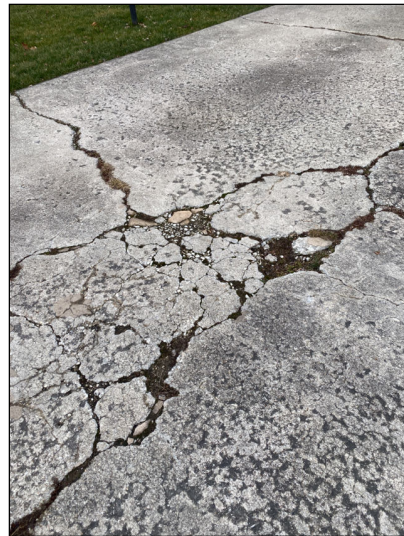
1. Driveway/Walkway Condition

- Uneven walking surfaces are present on this property at the walkway. In my opinion this is considered a trip hazard and can lead to injury. I recommend that you contact a qualified contractor to correct the situation.
- Uneven walking surfaces are present on this property at the driveway. In my opinion this is considered a trip hazard and can lead to injury. I recommend that you contact a qualified contractor to correct the situation.

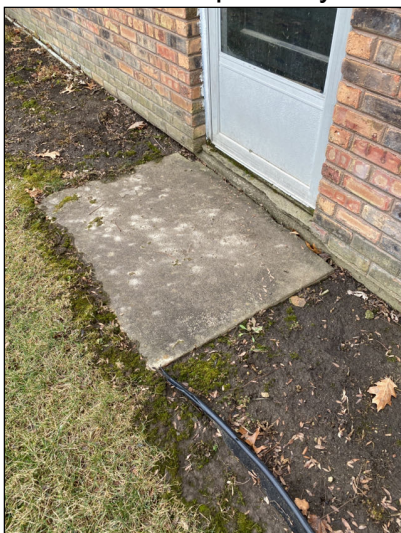
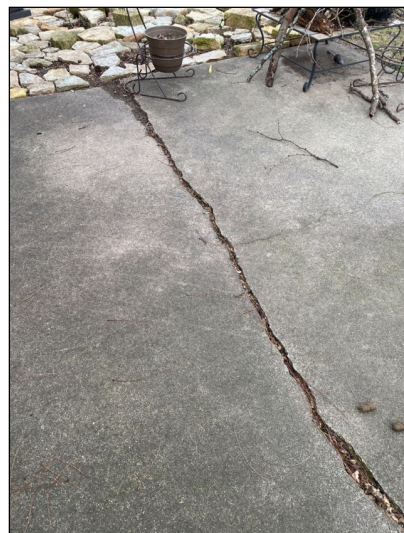
2. Porch/Patio/Deck/Balcony Condition

- The patio is improperly sloped towards the foundation. Water can infiltrate into the interior. Recommend repairing or replacing the patio to properly slope away from the foundation.

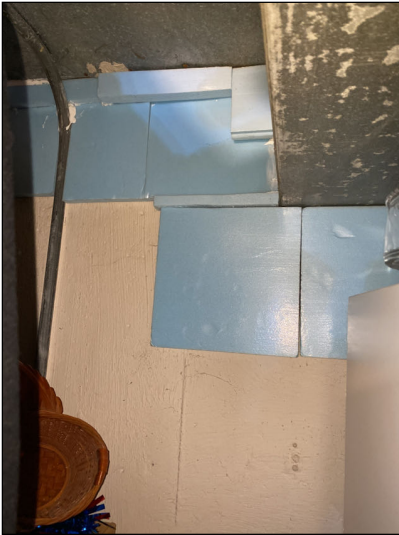
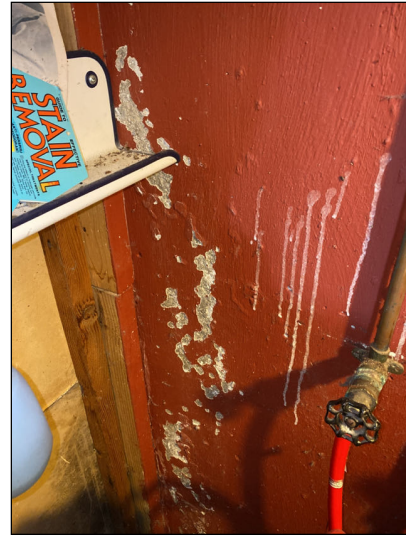
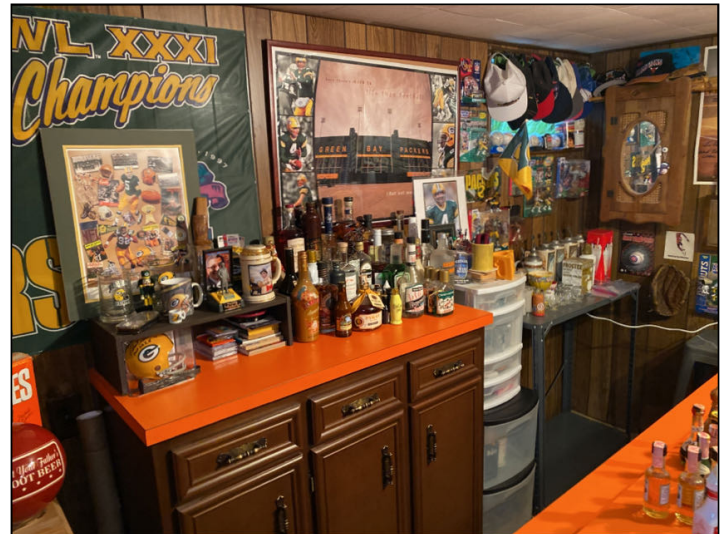
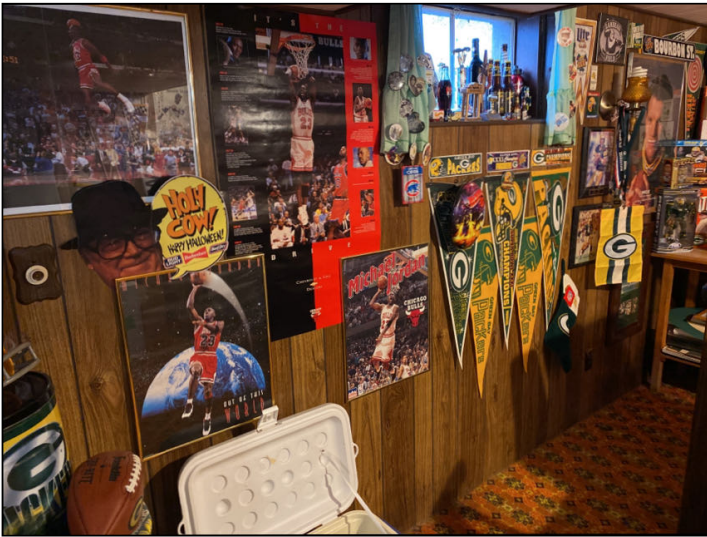
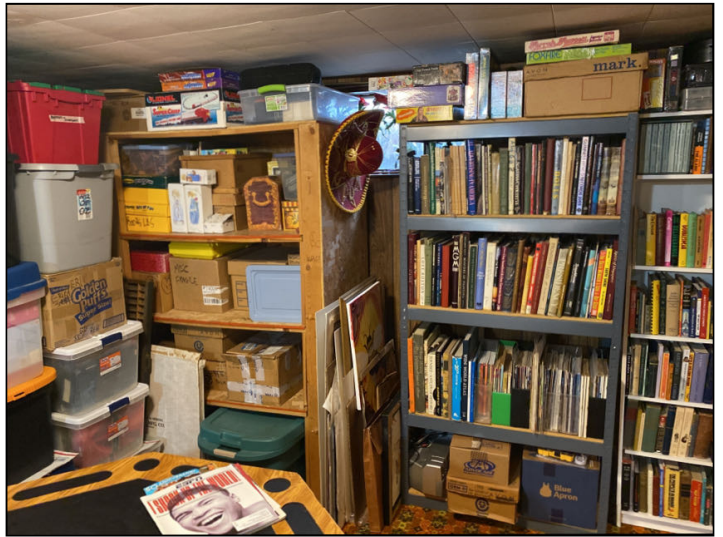
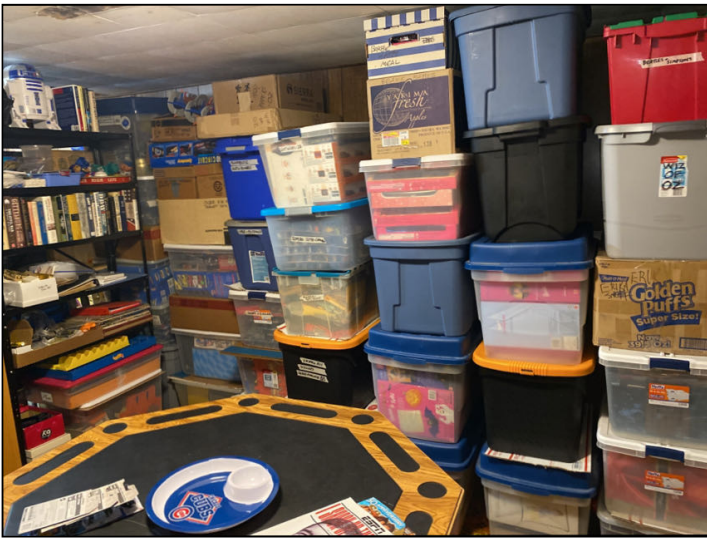
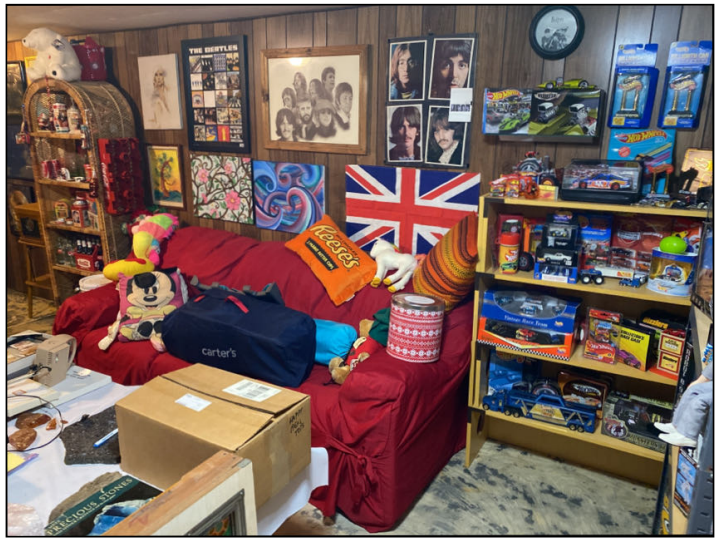
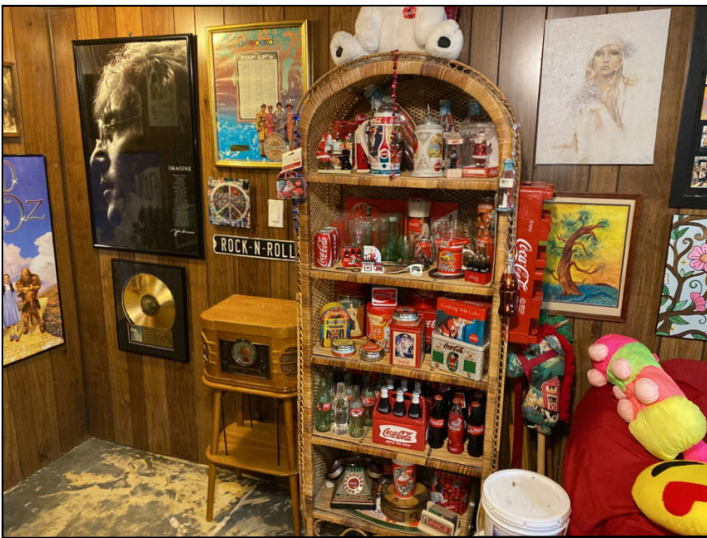
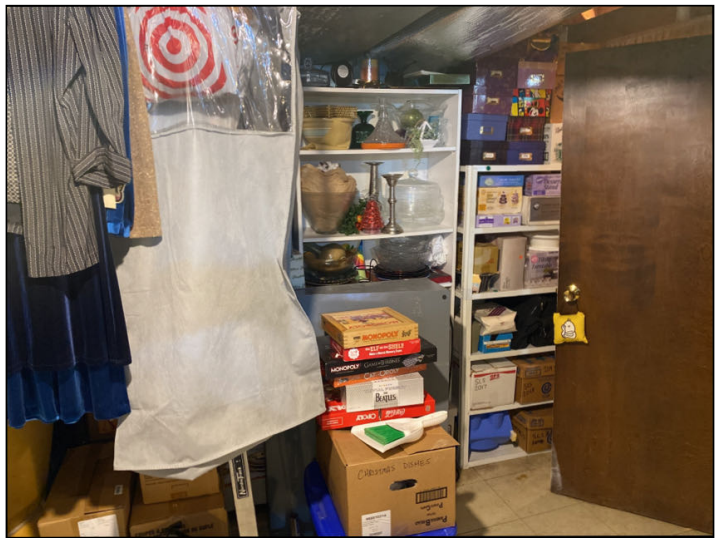
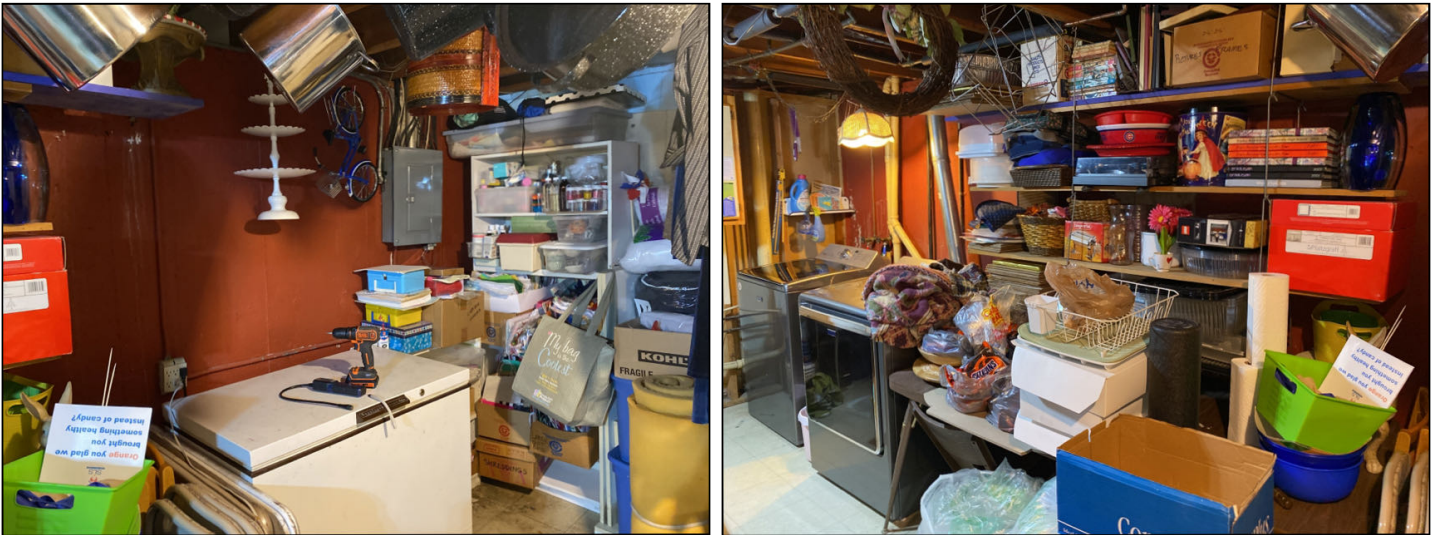
1. Foundation Condition

- Spalling is present. In my opinion this indicates water is inside the structure and causing damage. I recommend you contact a foundation contractor to mitigate the issue.

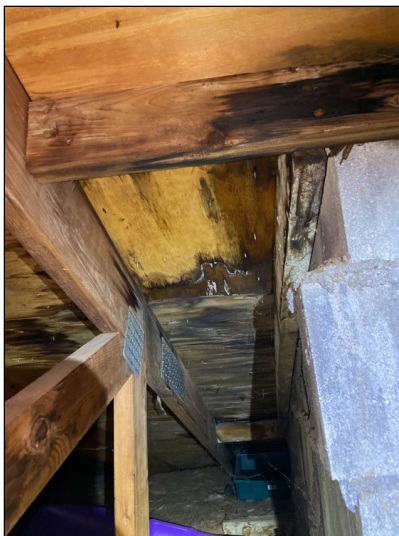
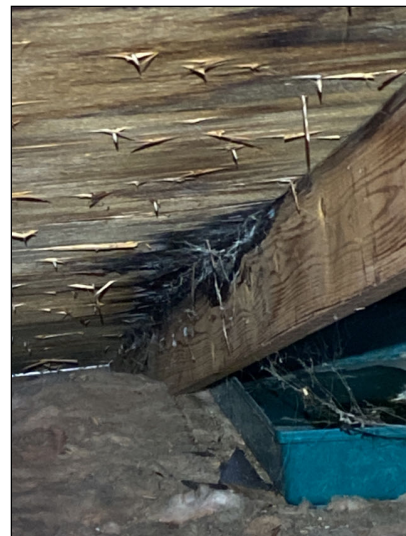
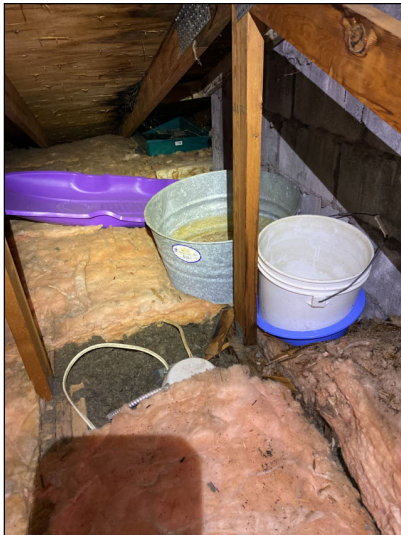
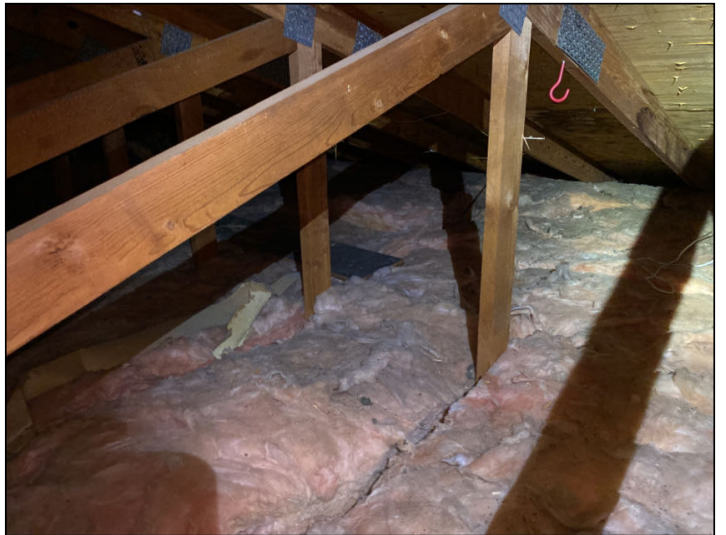
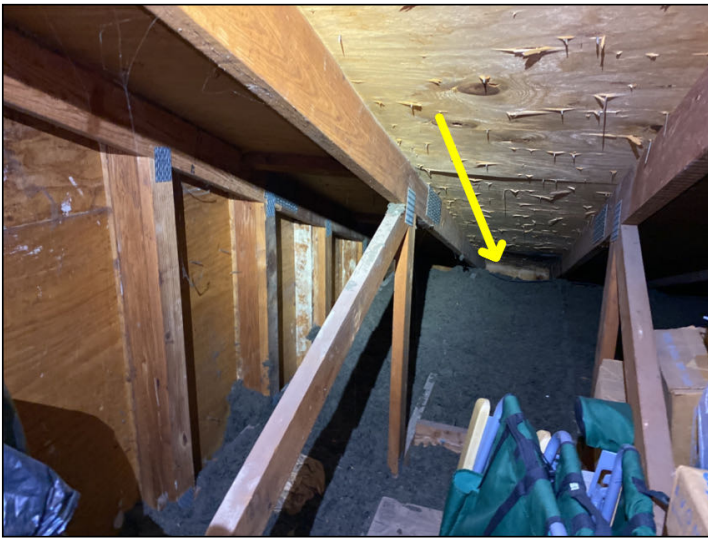
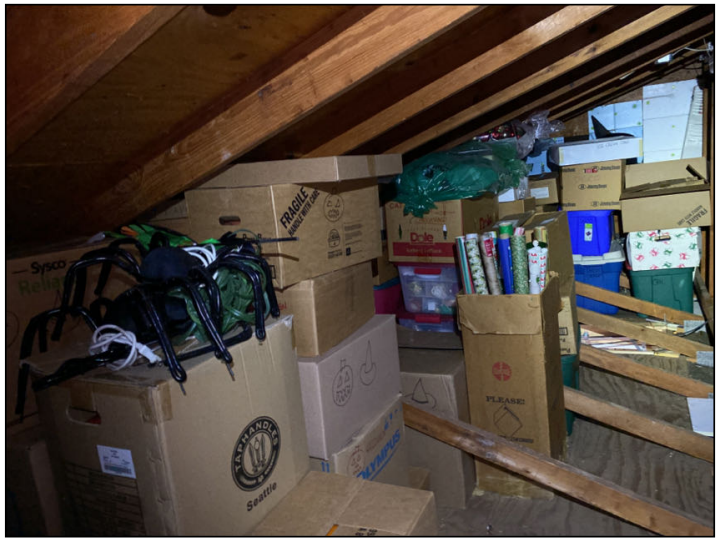
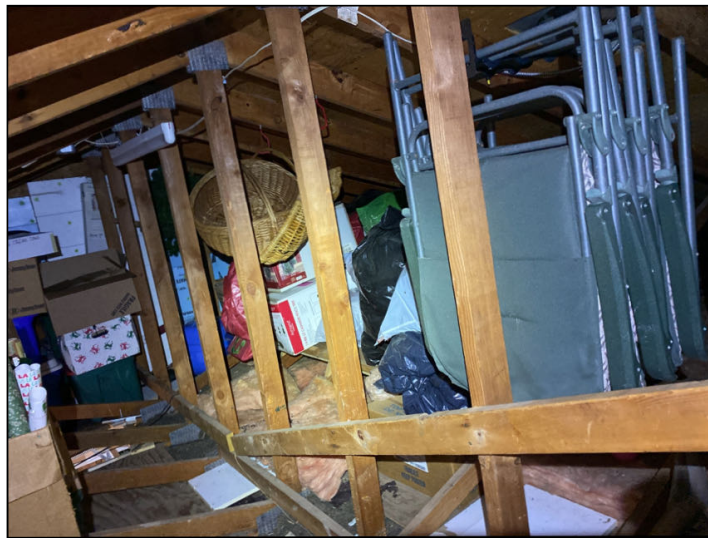
5. Roof Framing Condition

- Mechanical / physical damage is present at the roof sheathing. In my opinion this damage should be repaired. I recommend that you contact a qualified contractor to mitigate the issue.
- Signs of active water leakage/seepage are present in the roof. In my opinion water leakage can cause various problems and damages. It can even lead to structural problems. I recommend you contact a qualified roofer to correct the issue.

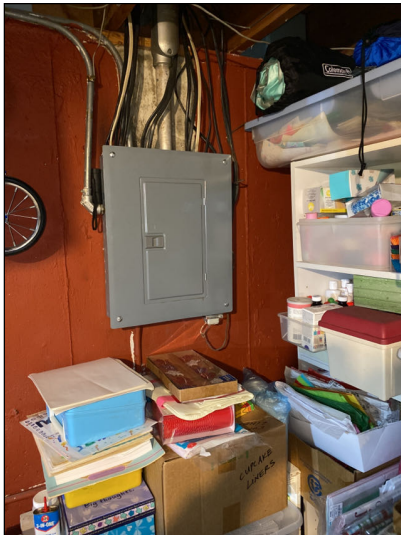
- The electrical panel has less than three feet clearance to the front and sides. In my opinion less than three feet clearance can be an increased shock / electrocution hazard for those who need to access the panel. However, based on the age of the house and installation this was likely the accepted method in the past. This is not a code compliance inspection and we are not suggesting correction because a more modern code is different than those in the past. This information is being made so you are aware of the conditions in this home although appropriate corrective action is recommended by a qualified contractor.

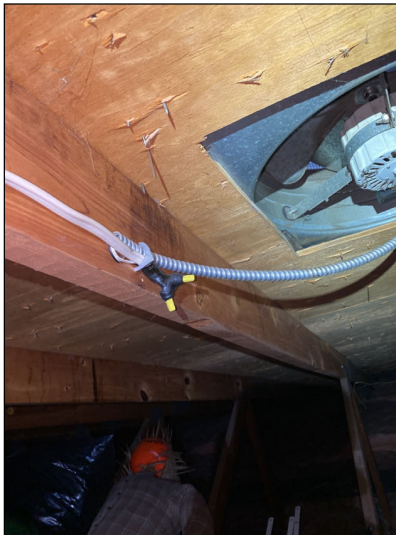
- Open wiring and splices are present and are not in appropriate junction boxes or enclosures in the attic. This is an increased fire and shock hazard issue and needs to be corrected by a qualified electrician.
- Cover plates are missing at junction boxes as observed in the attic. All junction boxes need to be covered so there are no exposed wires. Exposed wiring is considered to be a safety hazard. Appropriate cover plates are recommended.

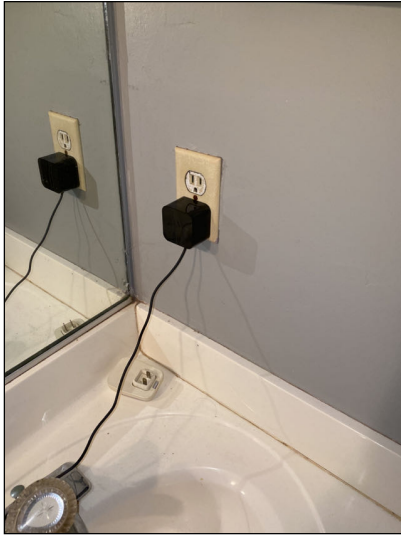
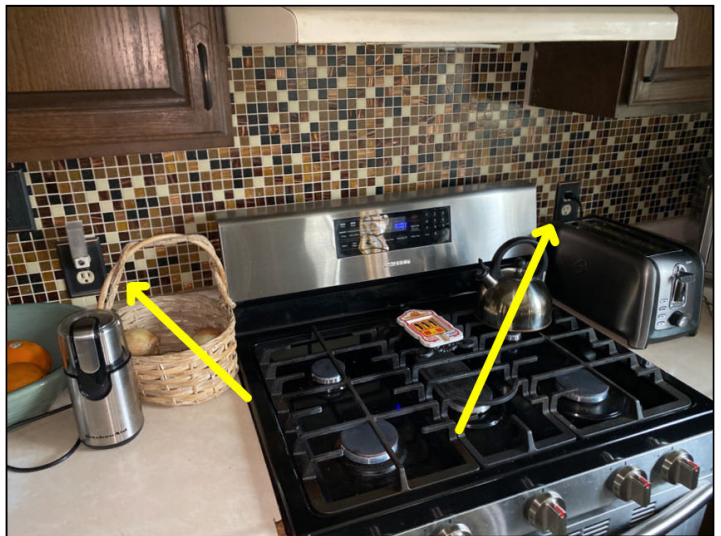
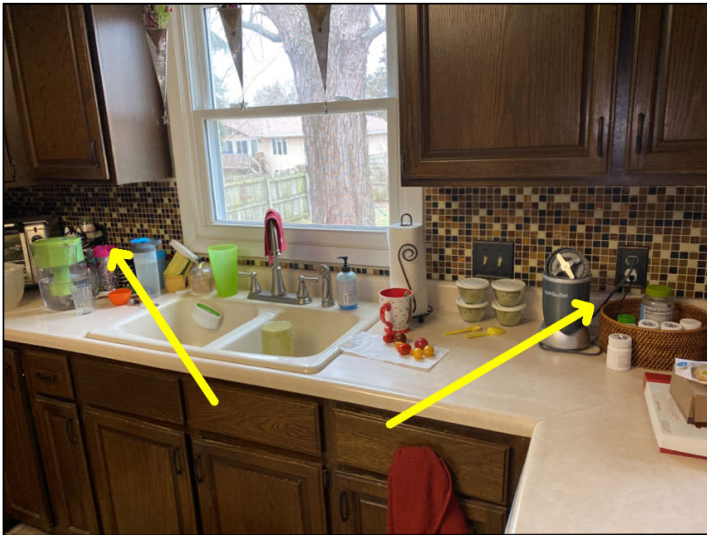
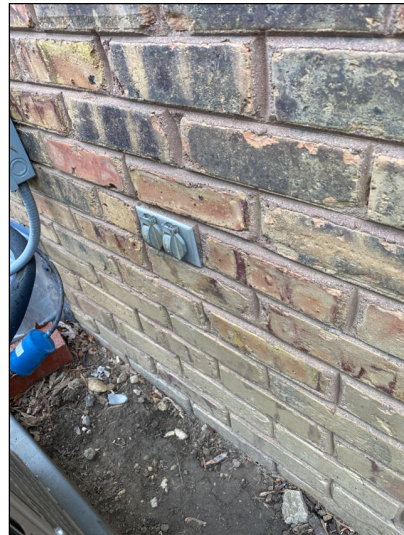
7. Outlets Condition

- The bathroom, kitchen, garage, outdoors electrical receptacle(s) is not GFCI type. A lack of a GFCI receptacle in this location is considered to be an increased safety risk and an electrical shock / electrocution hazard. Upgrading and installation of GFCI receptacles for optimum safety is recommended.

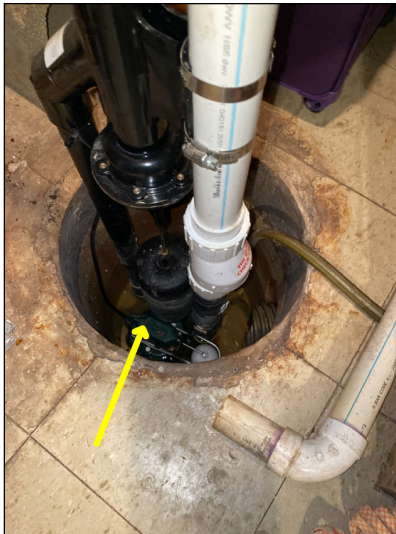
3. Sump Pump Condition

- The lid is not present. It is my opinion that someone can step in and get injured. Objects can fall into the pit and obstruct the float ball. This can cause flooding in the house. I recommend that you contact a reputable plumber or handyman to mitigate this issue.

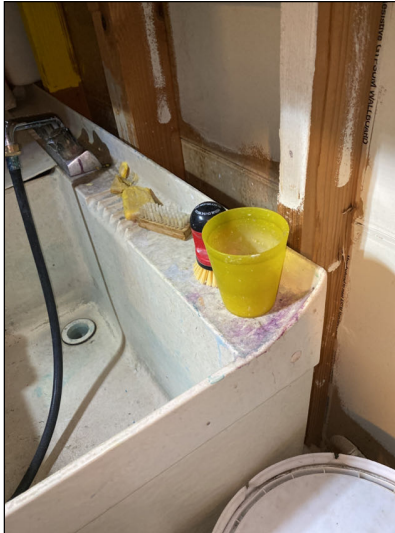
4. Laundry Tub Condition

- This item is not secure. Appropriate corrective action is recommended by a qualified plumber.

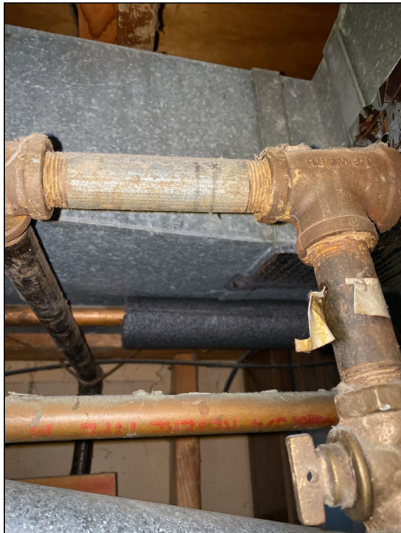
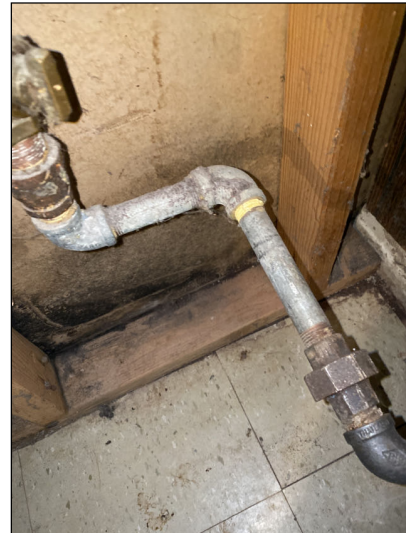
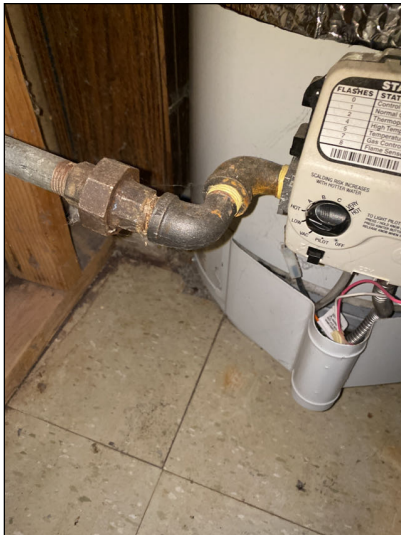
5. Water Heater Condition

- The gas piping does not have a drip leg or dirt leg present. This prevents debris from causing damage to the burner. Corrective action is recommended by a qualified mechanical contractor.
- The gas piping has galvanized pipe sections present. Although gas piping should be black iron (commonly called black schedule 40), galvanized pipe has been proven to work effectively for many years. However, many plumbing and HVAC contractors consider this inferior and often recommend changing the pipe.

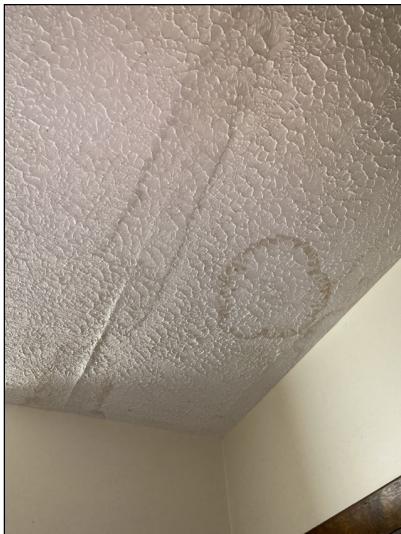
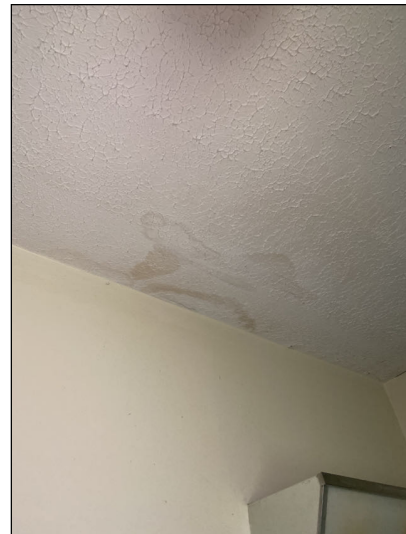
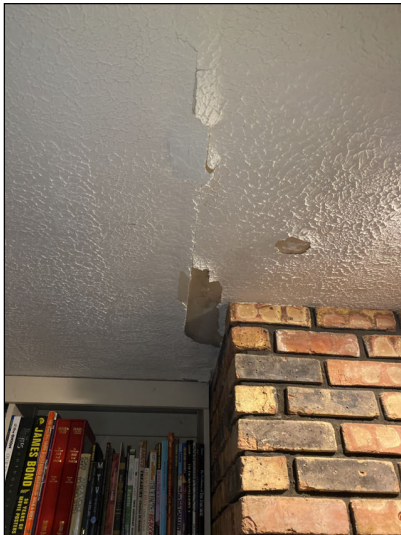
4. Ceiling Condition

- Water stains, deterioration or similar are present. This generally indicates some type of water / moisture entry. Before the end of the inspection contingency period, consult with seller to determine if water source has successfully been repaired.
- Expected cracks, blemishes, nail pops and similar are present. In my opinion these are common conditions and are likely to be cosmetic. Repair is recommended to obtain a better quality finish but will not likely affect performance.

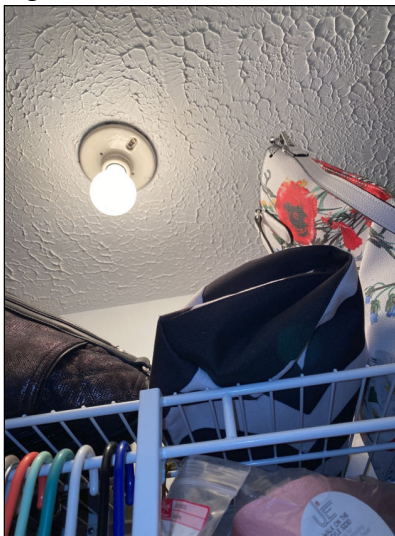
- Bare light bulbs are present in the closet(s). This can be a potential fire hazard if clothing comes in contact with an exposed light bulb. Recommend installation of light fixtures with covers.

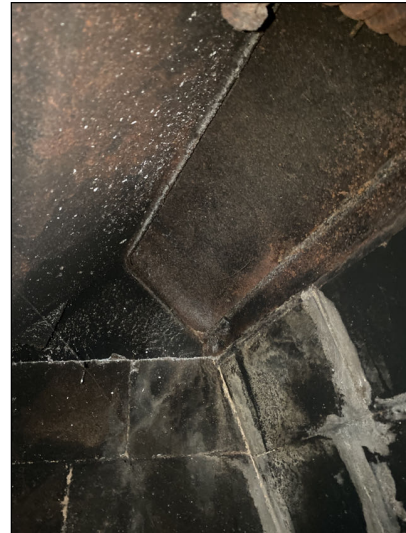
11. Fireplaces Condition

- SAFETY - There is a build up of creosote and debris in the fire box, smoke chamber or flue. In my opinion this is a fire hazard. Cleaning and servicing is needed by a qualified chimney sweep.

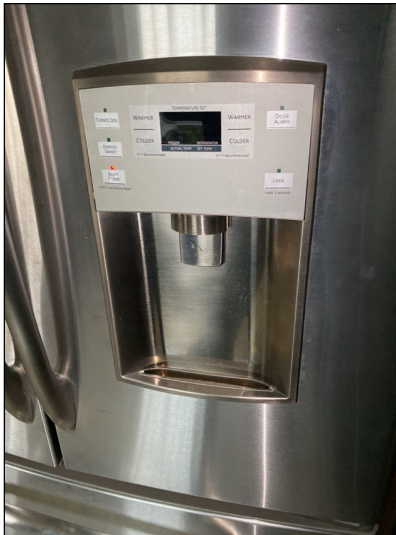
- The ice maker and/or water dispenser is not working. Recommend repair by qualified appliance technician.

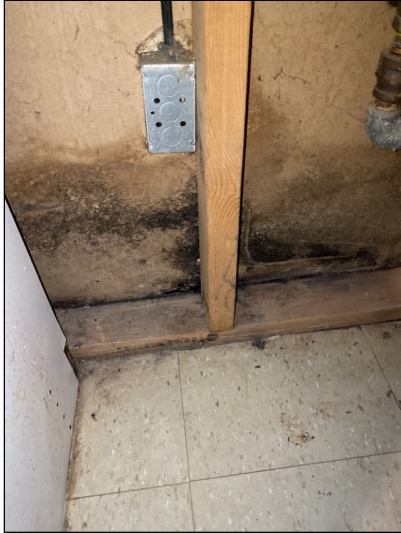
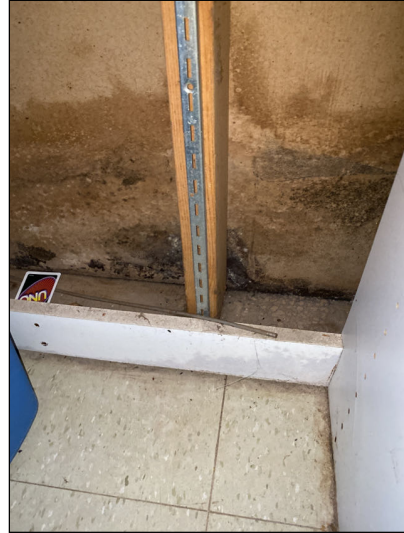
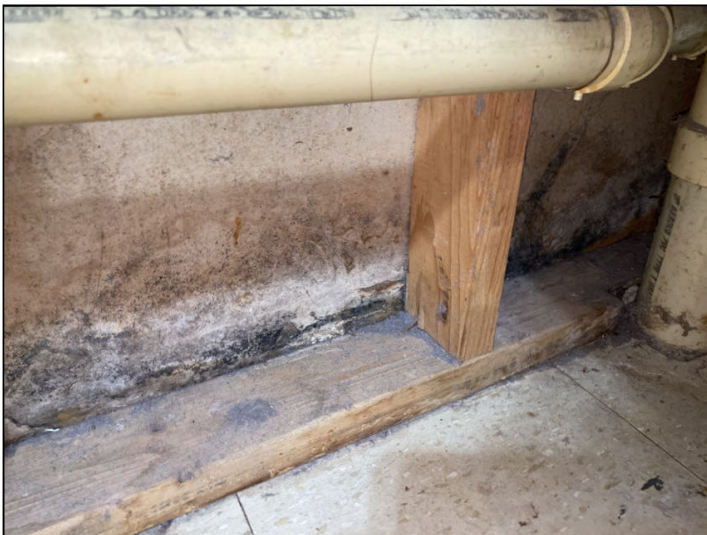
- **SAFETY** - This inspection excludes all environmental conditions. However, discolored building materials are present in the basement and in my opinion may be mold but cannot be confirmed without testing. Mold can create an indoor air problem and is considered by some to be a health hazard. Appropriate mold mitigation is recommended by a qualified contractor. Additionally, if there is mold there is a water / moisture problem. Evaluation and corrective action of the water entry or moisture problem is needed by a qualified contractor.
